Conservation and restoration of a modernist mosaic from Lluís Bru or Mario Maragliano: a new type of chromatic reintegration?

Núria Avecilla Palau - avecillapn@diba.cat Oficina de Patrimoni Cultural (OPC), Diputació de Barcelona
(in collaboration with Florencia Florido – florencia.f@zoho.com)

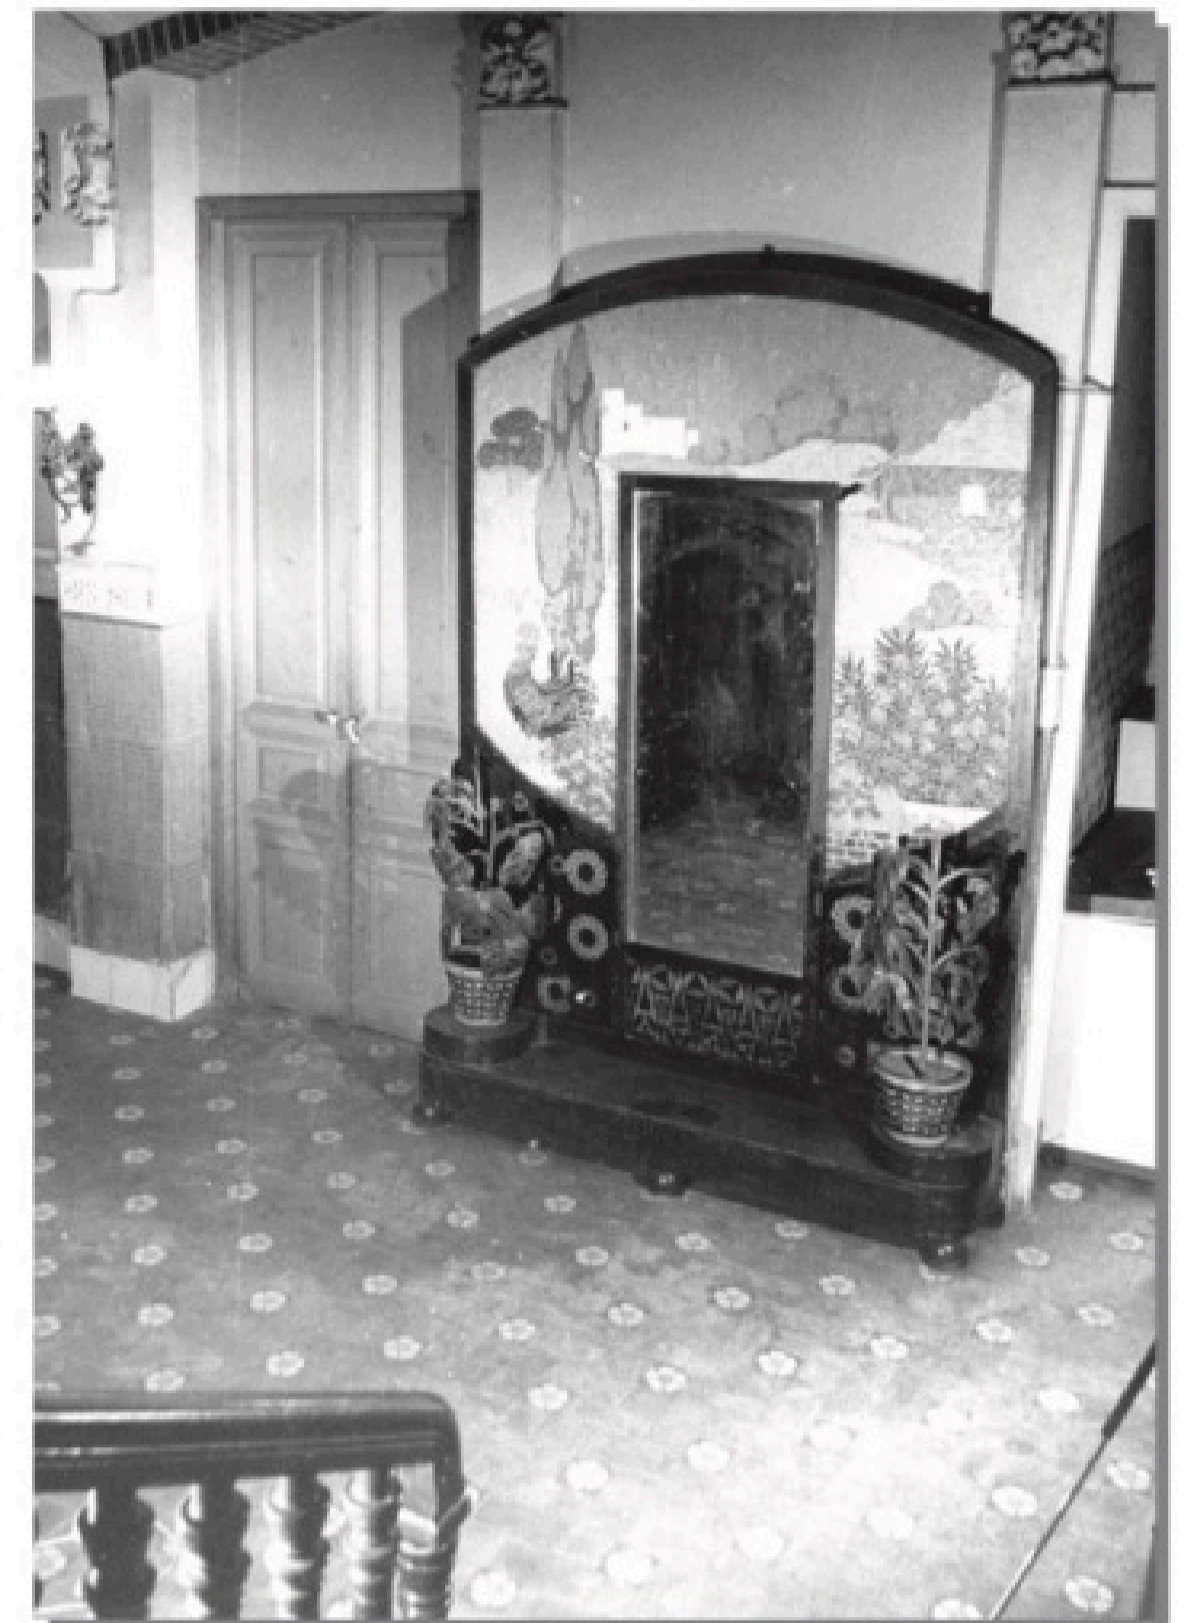
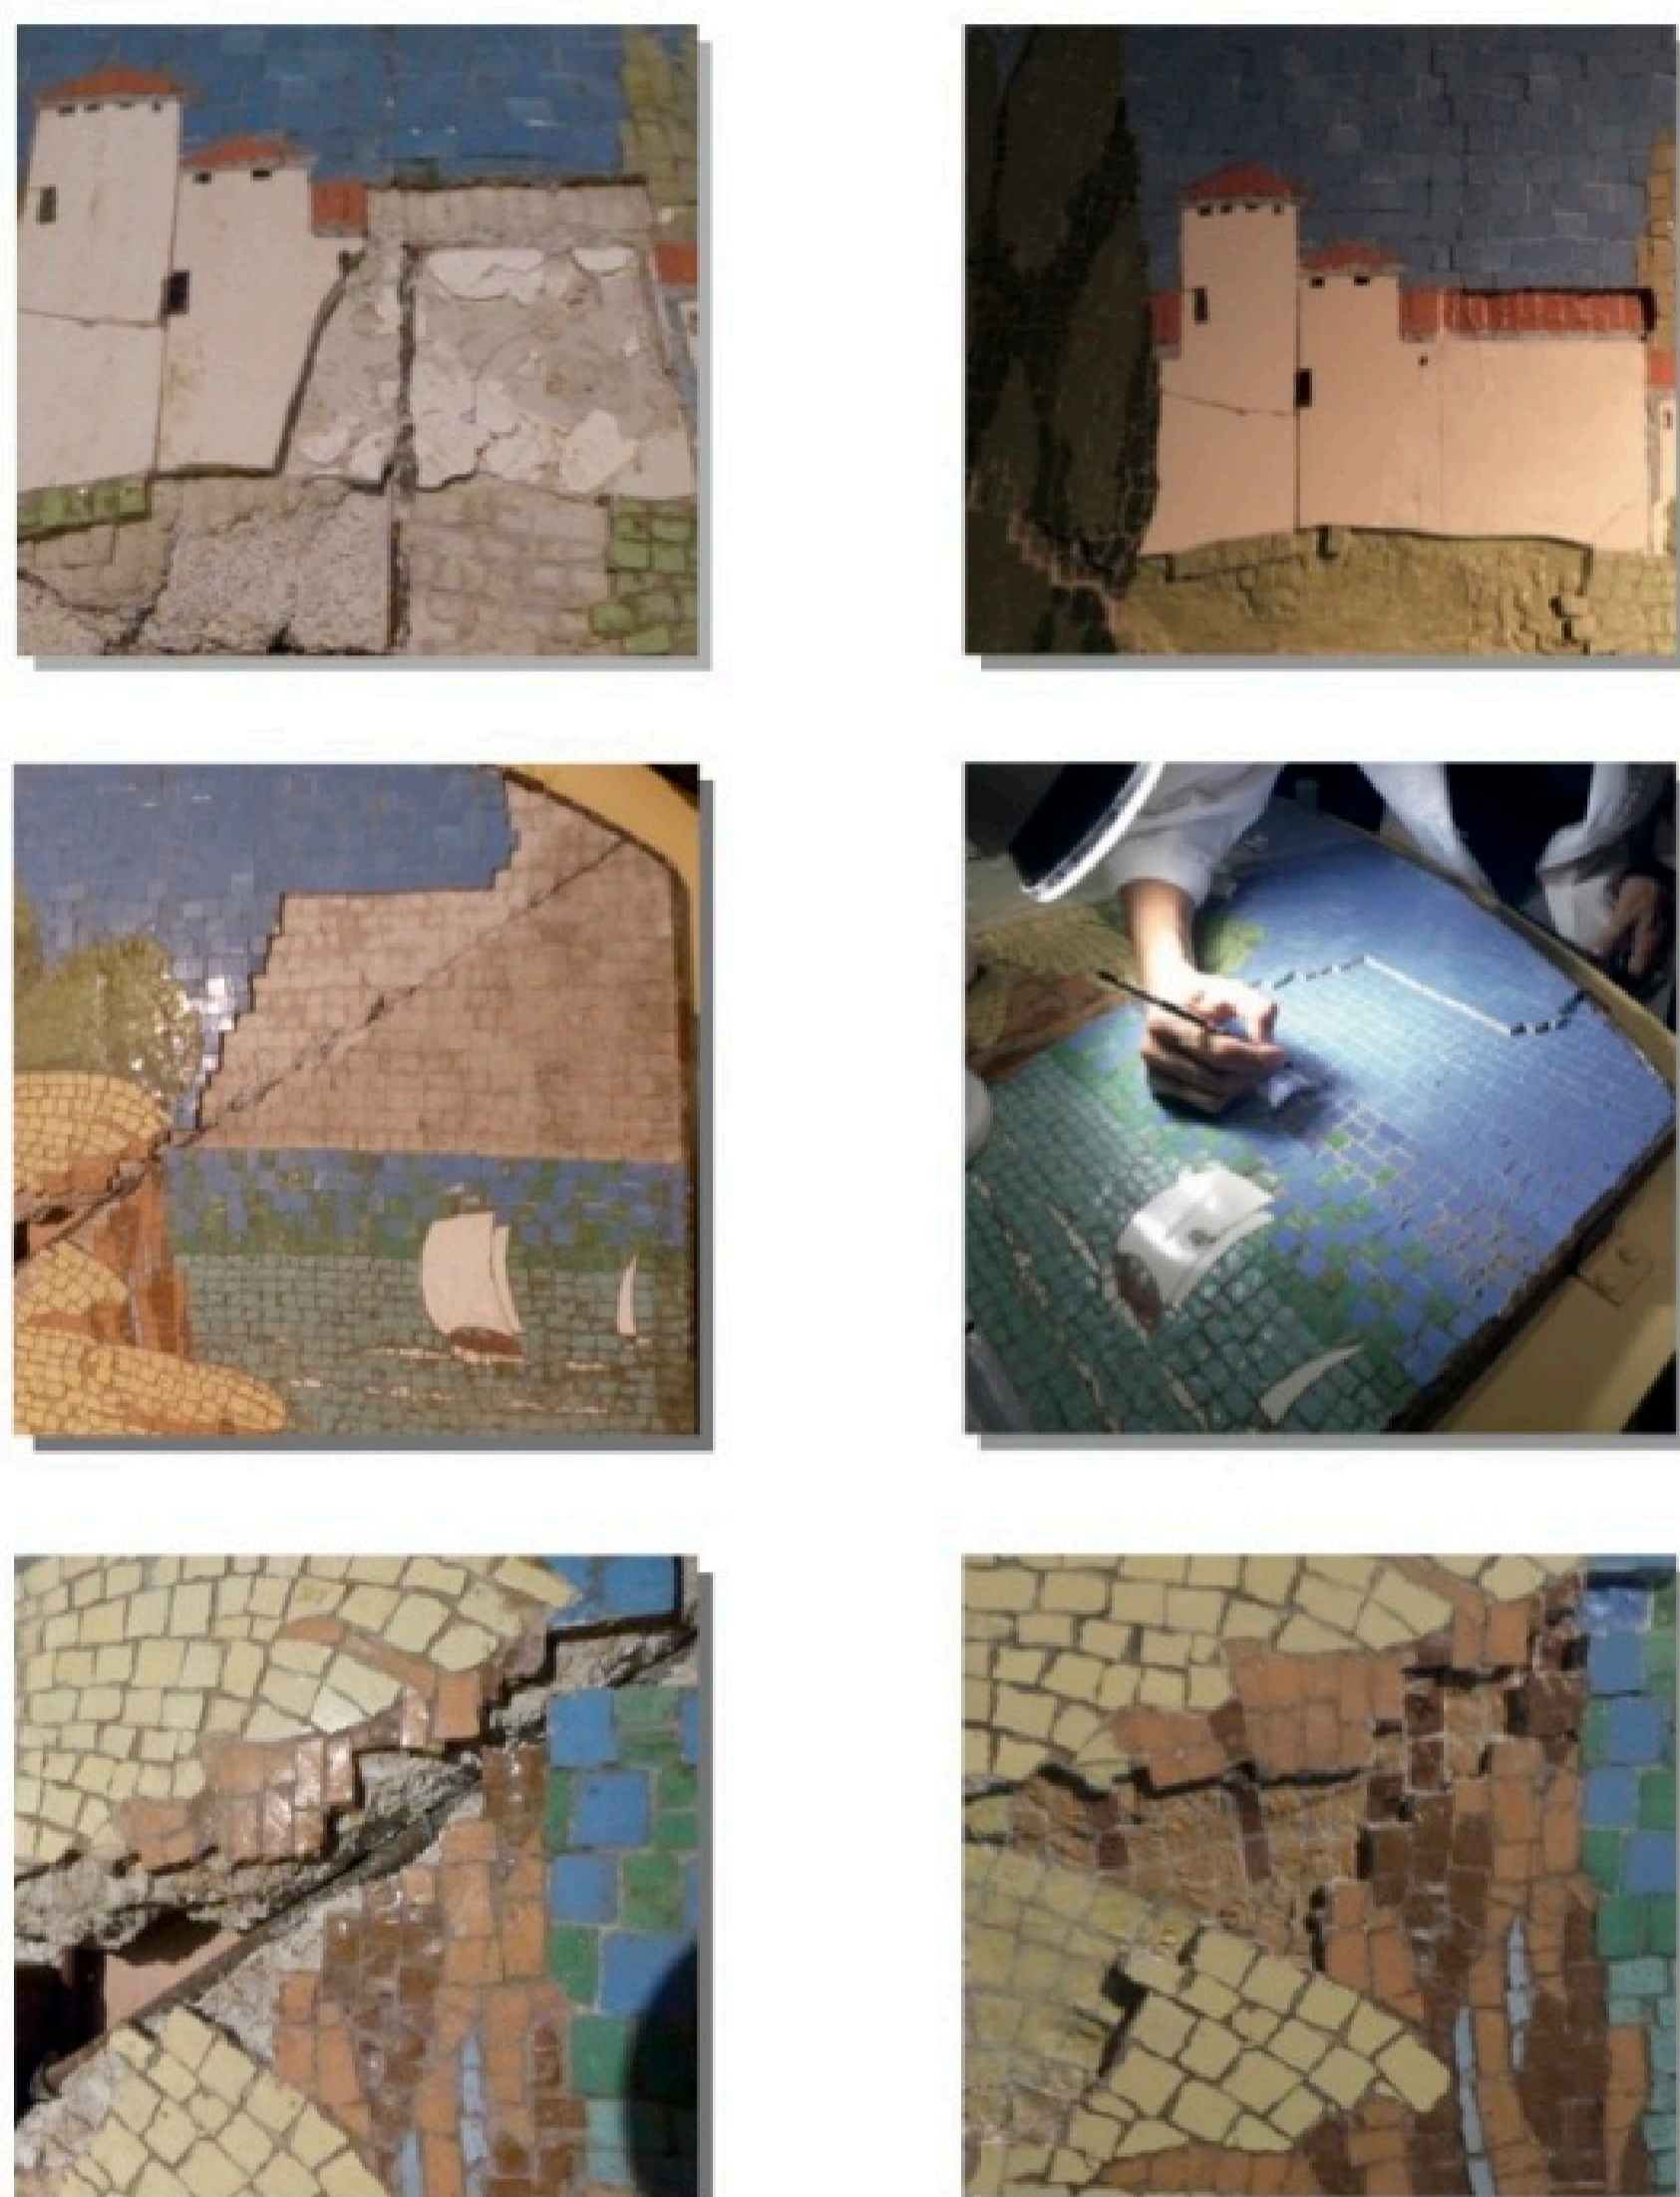
In 2015, the OPC's conservation department performed an on-site intervention of a modernist mosaic located at the Casa-Museu Lluís Domènech i Montaner, in the sea-side town of Canet de Mar. In origin, the mosaic decorated a mirrored entryway-furniture piece but, some time in the past, it was transferred to a new support made of painted wood. The condition assessment primarily documented damage of the mosaic's internal iron structure, which had expanded along the upper corners due to corrosion mechanisms triggered by internal and external causes. Consequently, this force fractured the overlying mortar of the tesserae, which in turn were detached from the expansion area and eventually got lost.

Details before and after the intervention

- General cleaning of the mosaic.
- Cleaning and inhibition of the exposed iron structure corrosion.
- Consolidation and repair of tesserae blistering.
- Filling of the setting-bed lacunae.
- Protective coating of the exposed original setting-bed mortar.
- Chromatic reintegration of the tesserae over the original imprints.
